USFA FIRE BURN PATTERN TESTS

REPORT OF
THE UNITED STATES FIRE ADMINISTRATION
PROGRAM FOR THE STUDY OF FIRE PATTERNS

JULY 16, 1997

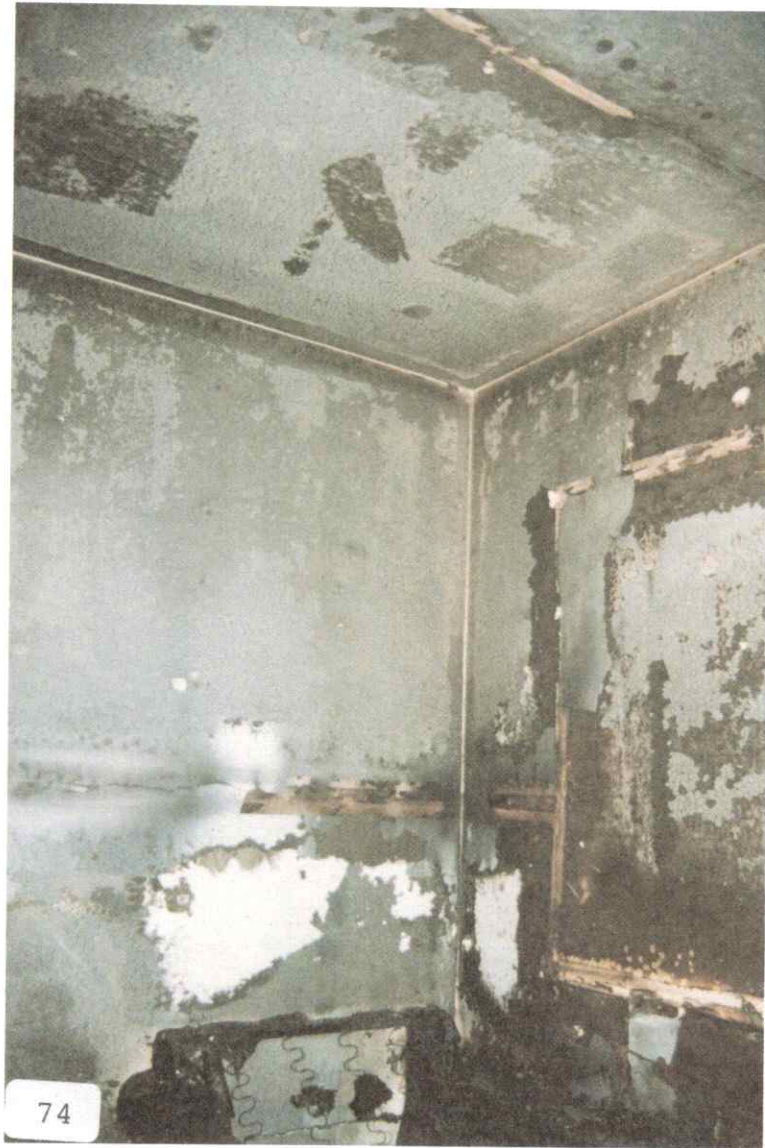
Photograph 74 (Test 9)

Photograph 74 also shows how the pattern from the fire plume extends around the corner and onto the wall to the right of the chair.

could be seen on the surfaces after flashover in varying quantities. Higher in the room and closer to the fire, the quantity of material was greater than that of other areas. When this material was subjected to the higher temperature of a fire plume or flame zone, this material was removed and produced a “clean” area. This is commonly referred to as a “clean burn.” Clean burns were evident in many of the test fires and the best examples were Tests 1 (photograph 2), 2 (photograph 11, 12, 13, and 15), 5 (photograph 28, 30, and 35), 7 (photograph 52 and 53) and 9 (photograph 73 and 74).

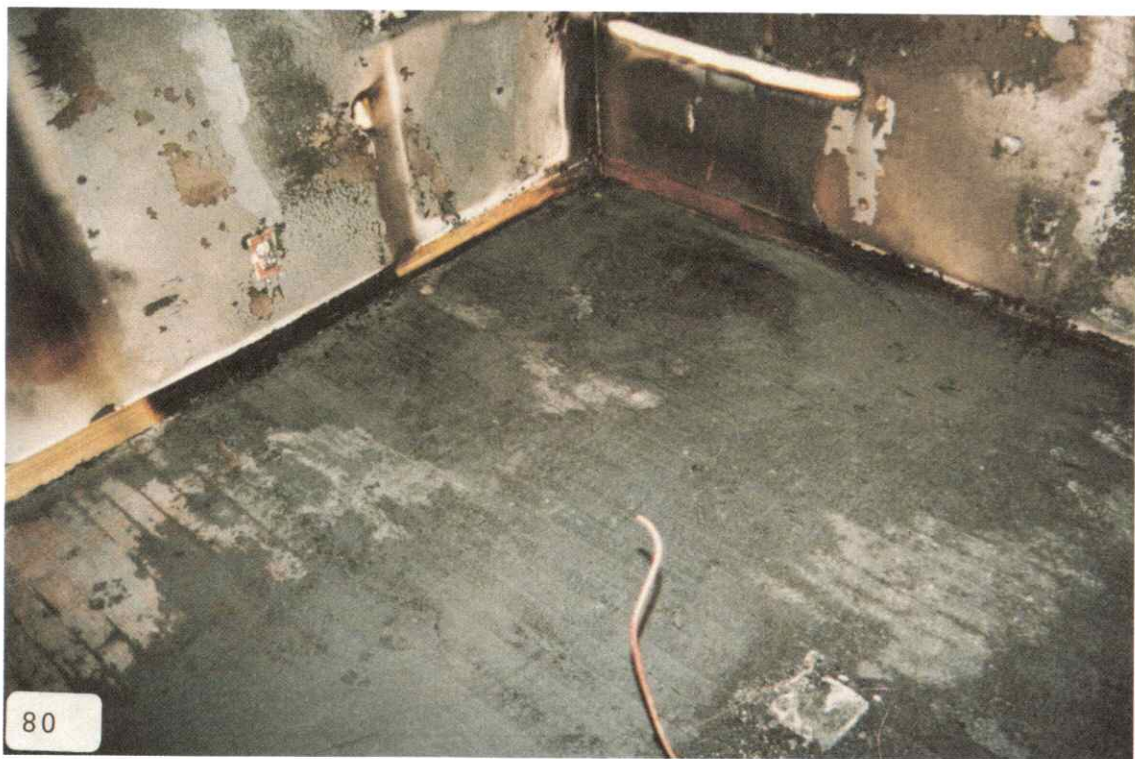
Photograph 80 (Test 9)

Photograph 80 shows the floor area in the corner of the room where the chair was located. The surface of the floor here is similar to that shown in photograph 79 except that there is a pattern produced by burning under the chair.

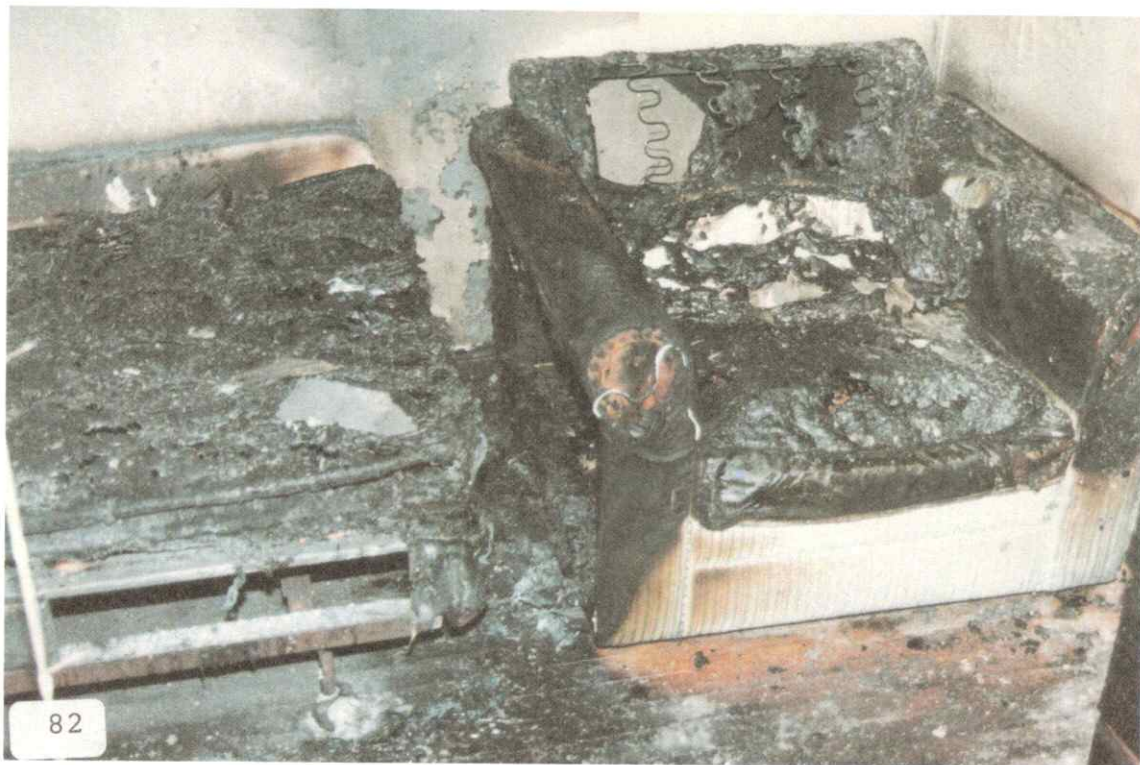
Photograph 82 (Test 10)

Photograph 82 shows the chair and the foot of the bed. The damage to the chair is greatest on the top and on the right side. The damage pattern on the left side of

9. Intensity patterns which were produced by relative differences in damage were useful in establishing the point of origin. In several cases, patterns were observed which would permit establishing the point of origin within a margin of inches. The best examples of this were Tests 3 (photograph 19), 4 (photograph 23, 24, and 25), 5 (photograph 37, 38, and 39), 9 (photograph 73, 75, 76 and 81), and 10 (photograph 82).

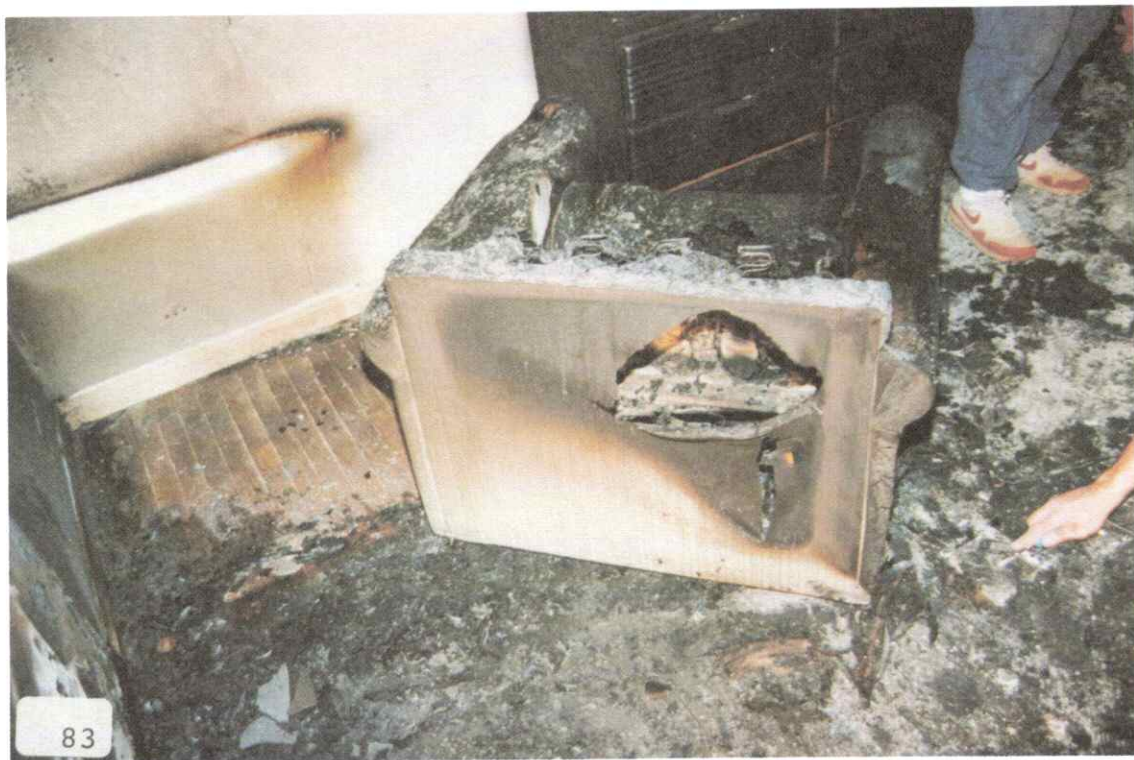
Photograph 83 (Test 10)

Photograph 83 shows the back of the chair and another damage pattern which indicates that the origin of the fire was to the left of the chair toward the bed.

gasoline which was poured in this area to start the fire. As indicated by the pattern, some of the gasoline flowed behind the chair and burned there. This pattern could not have been caused by flashover because of the protection provided by the chair, and examination of photograph 83 will show that this part of the chair did not burn.

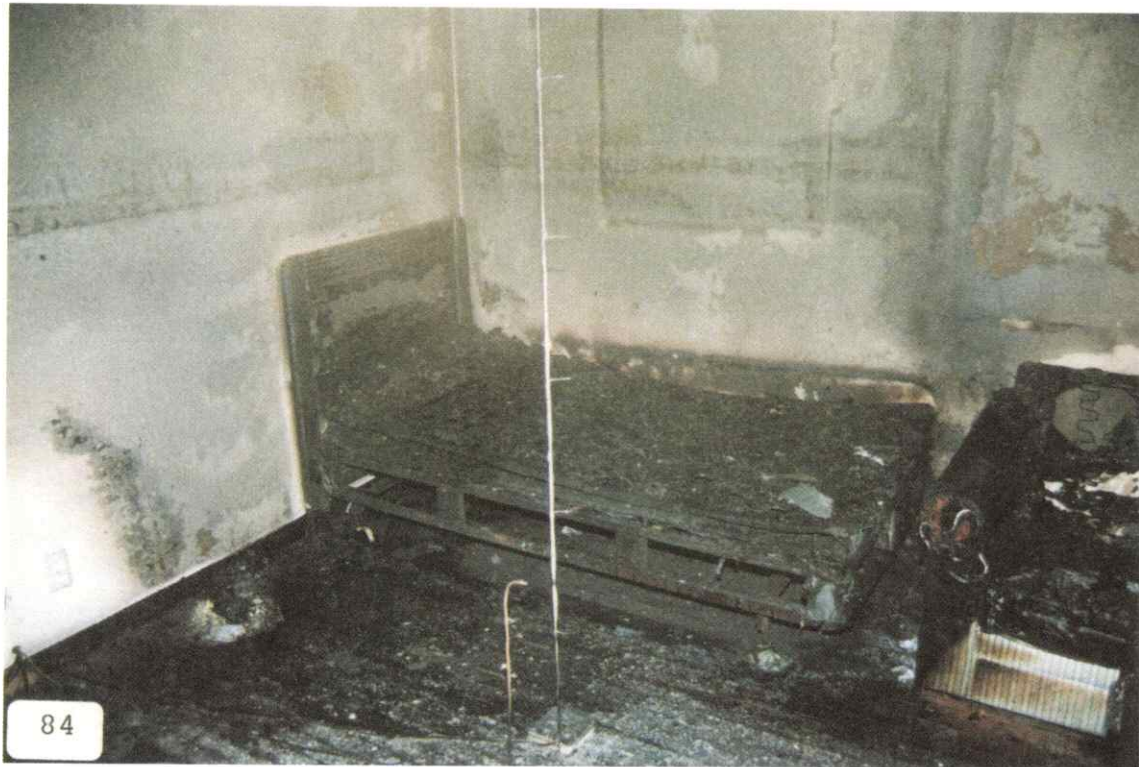
Photograph 84 (Test 10)

The damage to the bed is fairly uniform on the exposed surfaces as shown in photograph 84. The pattern on the walls adjacent to the bed indicate that there was fire in this area and that its base was closer to the foot of the bed than to the head. This is confirmed by the pattern on the wall behind and to the left of the head board of the bed.

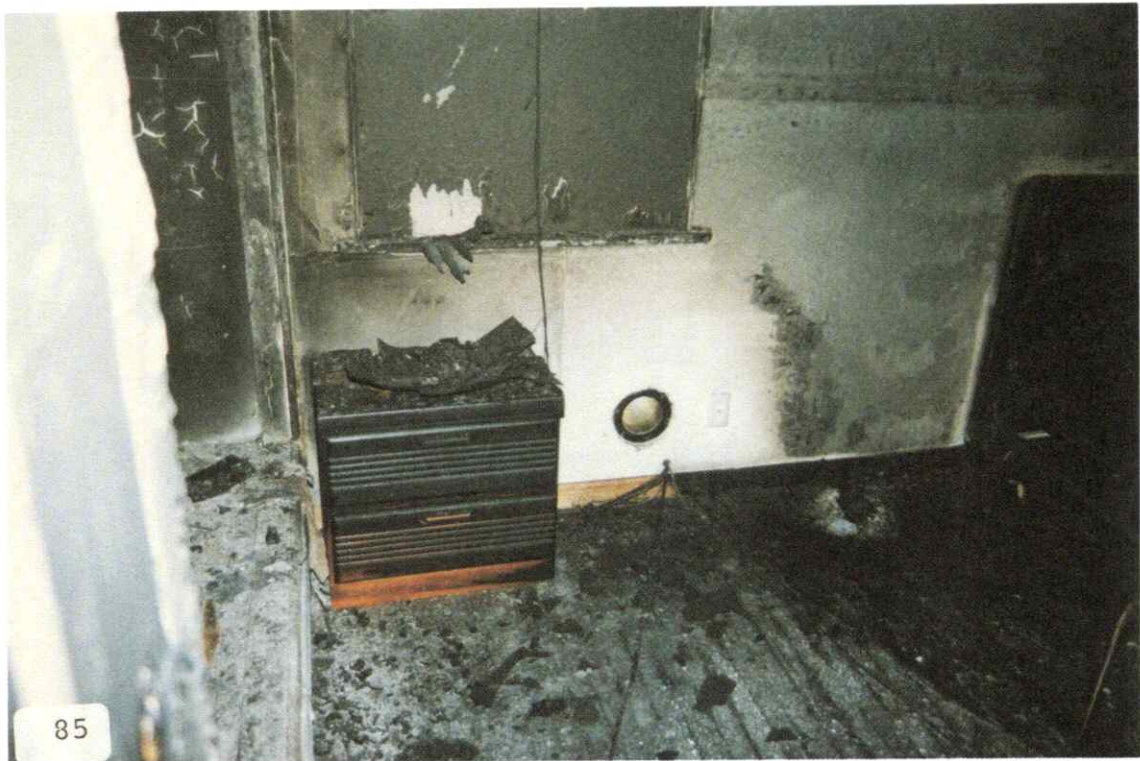
Photograph 85 (Test 10)

The remainder of this wall is shown in photograph 85 which also shows the bottom of the window and the night stand. The circular opening in the wall under the window was a view port for a video camera.

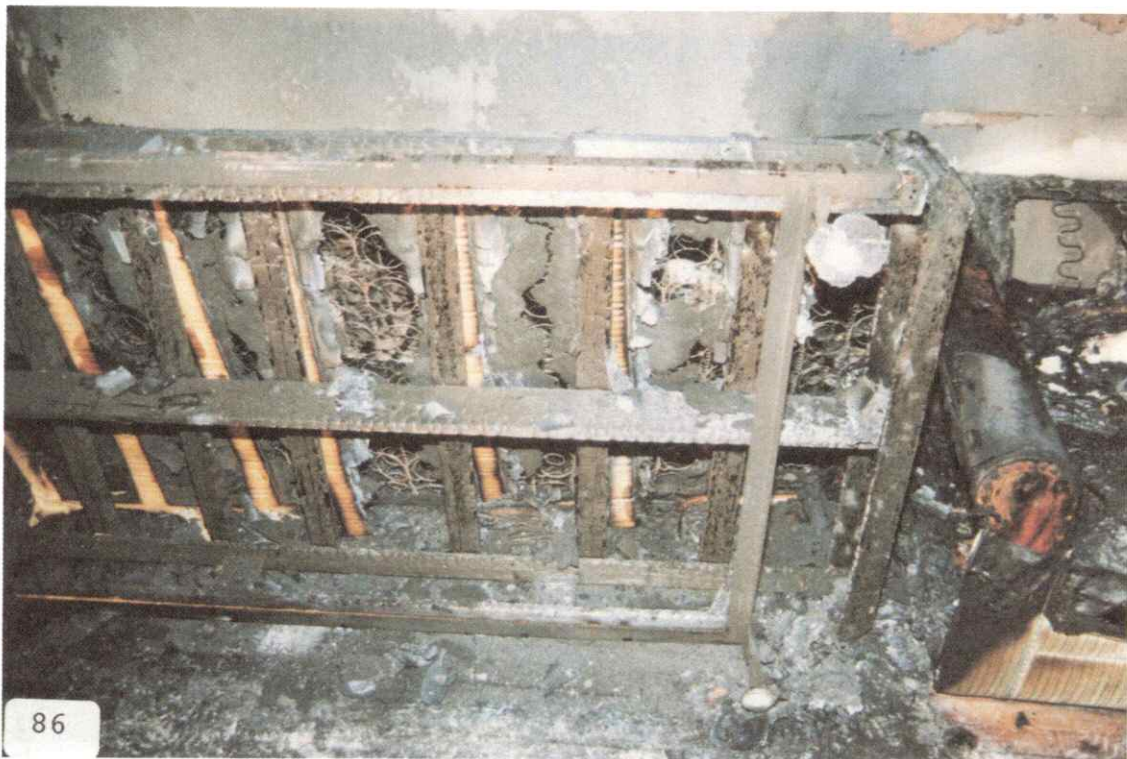
Photograph 86 (Test 10)

Under the bed, as shown in photograph 86 there is evidence that there was fire here and that it burned from the floor up. This is indicated by the protected strips of cardboard which had covered the top of the box spring. On the feet of the bed were plastic casters, one of which is visible in this photograph after it has melted and re-solidified.

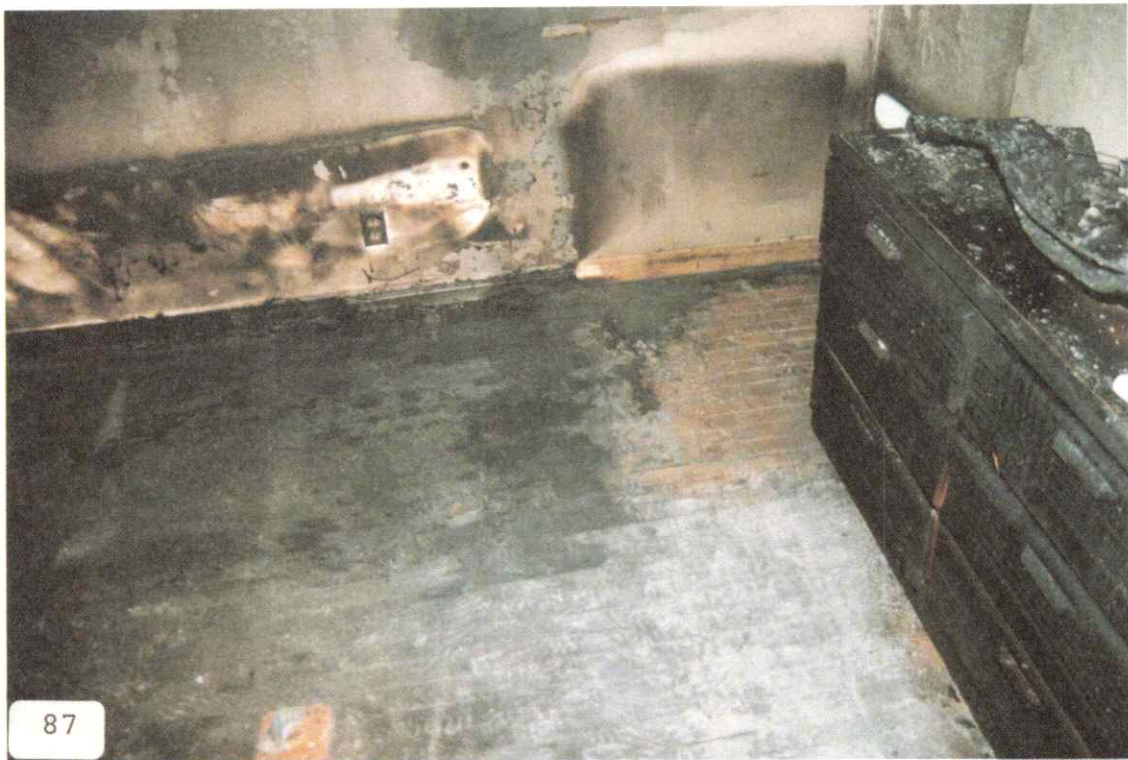
Photograph 87 (Test 10)

Photograph 87 is of the floor in front of the bed and chair. The darker area of the floor in the center of the photograph corresponds with the area between the bed and chair. The remainder of the floor shows fairly consistent and uniform damage except the area which was under the chair.

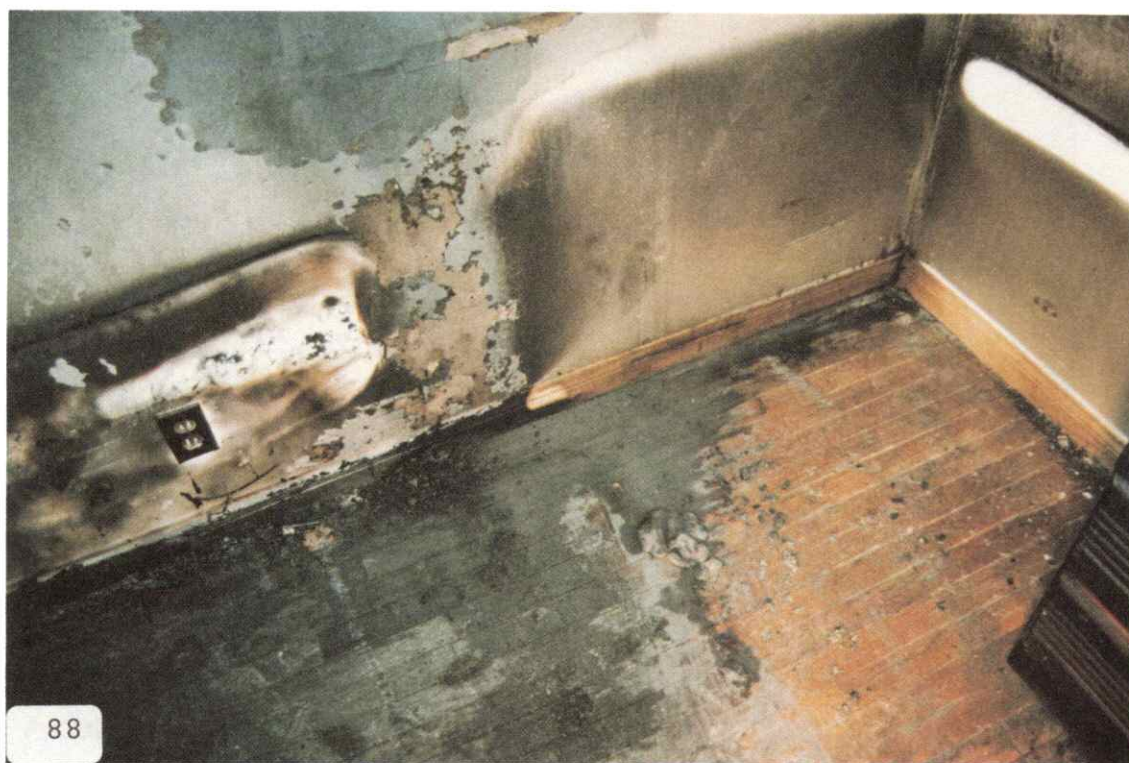
Photograph 88 (Test 10)

Photograph 88 is of the floor area which was near and under the chair in the corner. Visible on a portion of the floor which was under and behind the chair is a burn pattern. This pattern continues behind where the chair was and into the corner. The edges of the pattern are irregular. This pattern was caused by the

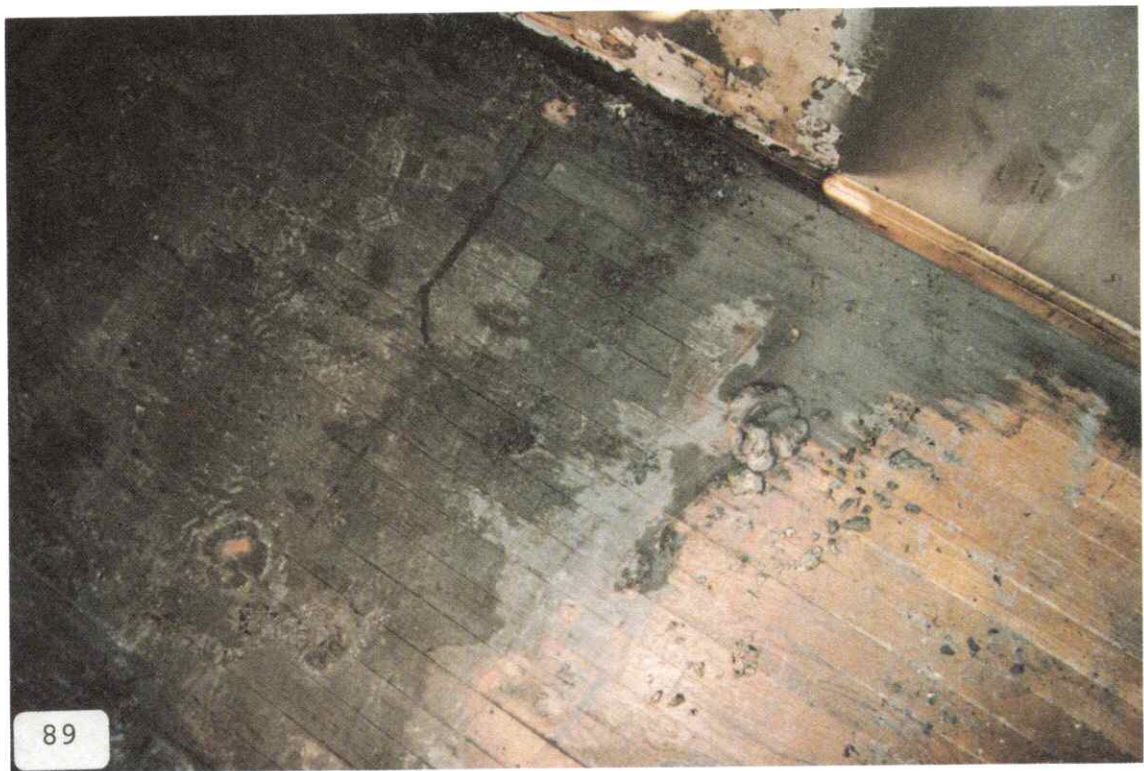
Photograph 89 (Test 10)

Photograph 89 shows a closer view of the floor area shown in photograph 88. The two small unburned circular areas on the floor are from the feet of the bed which protected these areas.

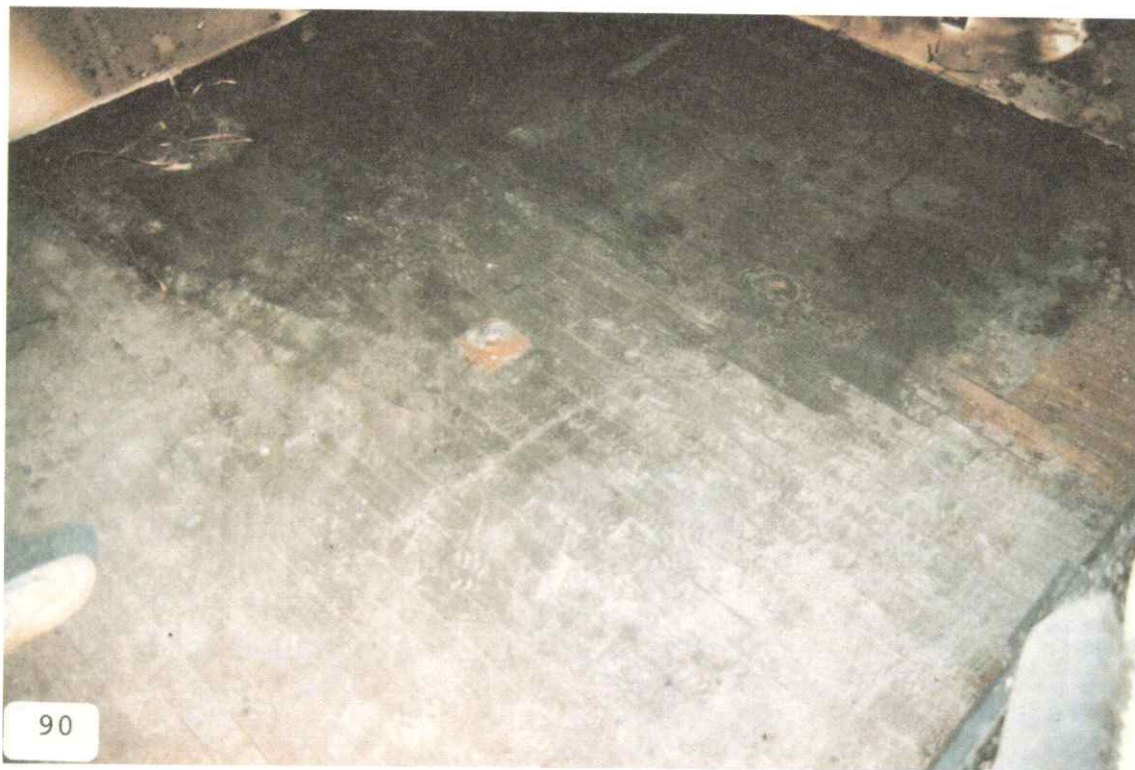
Photograph 90 (Test 10)

Photograph 90 shows a large portion of the test room floor after all debris was removed and the floor swept. Except for the floor patterns discussed above, there are no other floor patterns visible in this photograph which can be attributed to the burning of the gasoline pool.
